Corrosion discovered in a building  
less than five years old

# The real cost of cutting corners: corrosion discovered in a building less than five years old

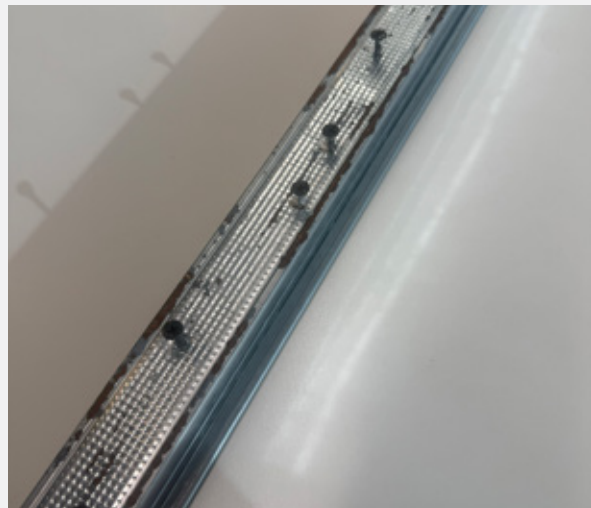
When the plasterboard was removed, rust was clearly visible on the imported steel framing behind it.

In less than five years, corrosion had already developed within concealed internal walls and ceilings

The affected walls and ceilings will now need to be pulled out. The imported framing will be removed and replaced with Rondo metal framing before the areas can be relined, replastered and repainted.

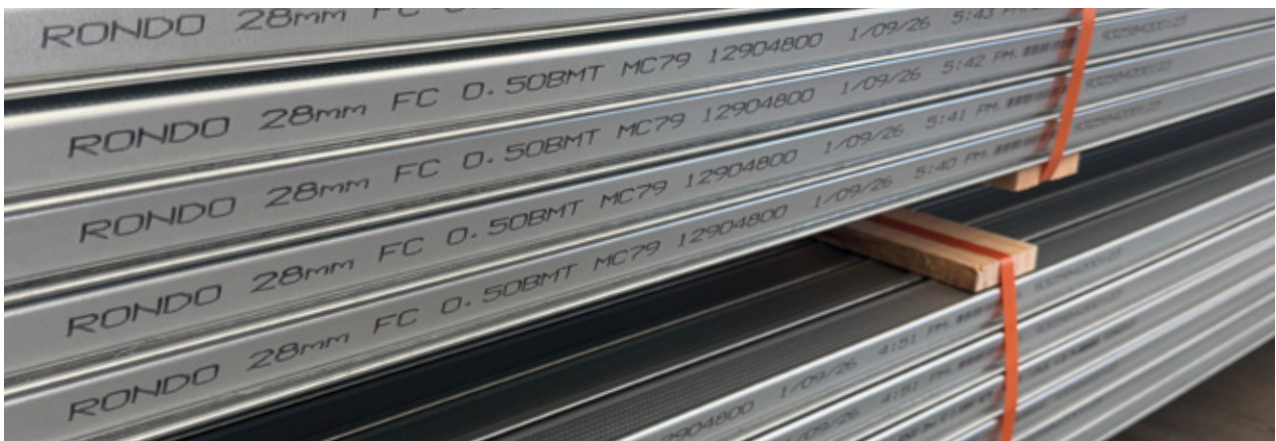
A framing product should not be accepted as equivalent simply because its dimensions or appearance seem similar. Look for the Rondo name inkjet printed or stamped on the metal product or clip to verify that genuine Rondo metal products has been supplied.

- **Specifiers** can require Rondo's inkjet branding as a simple way to confirm the specified products have been supplied.
- **Builders** can verify the inkjet branding when materials arrive on site and before walls and ceilings are lined with plasterboard
- **Installers** can check for the Rondo name before installing the framing and again before it is concealed behind plasterboard.
- **Certifiers** can use the visible branding to help confirm that genuine Rondo products have been installed before the walls and ceilings are lined.
